OWNER'S MANUAL

"The Unit" Air Fill Station

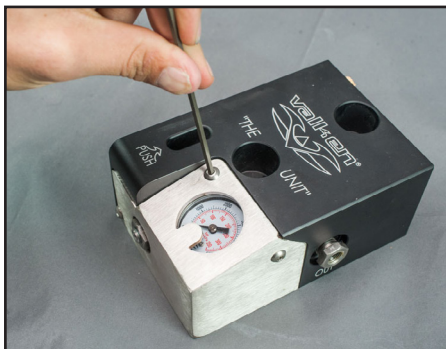
1. Remove the gauge cover plate by removing the (4) stainless steel screws using a 1/8" allen wrench.

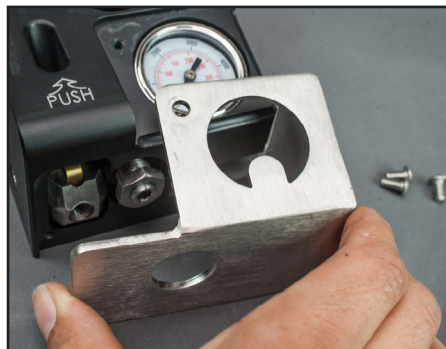
2. Remove the gauge cover and set aside.

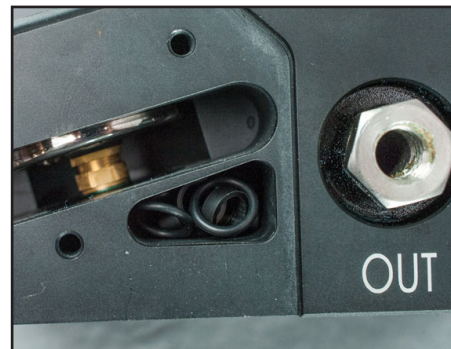
3. Location of the rebuild kit

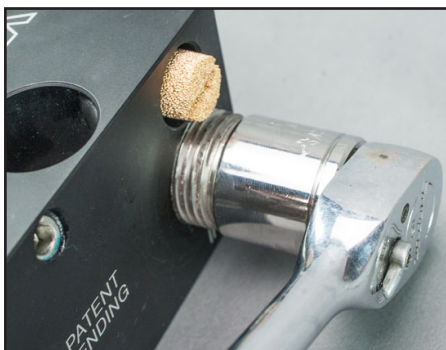
1. Remove valve cartridge using 7/8" ratchet. *May have to heat

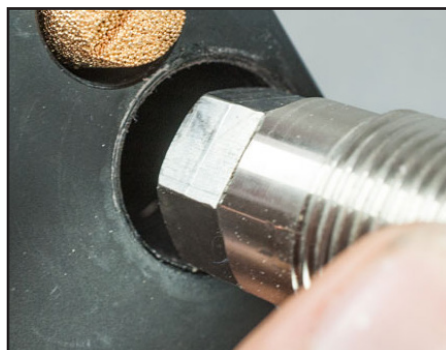
2. Completely remove valve cartridge from filling station.

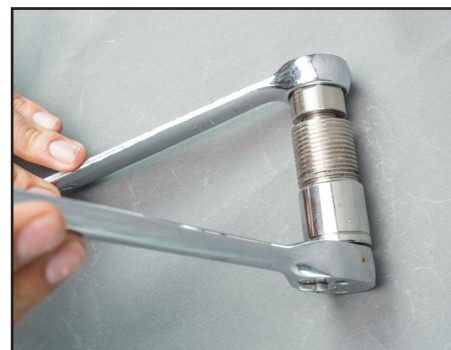
3. Using the 7/8" wrench and 7/8" socket, unscrew the valve cartridge cap. *May have to heat

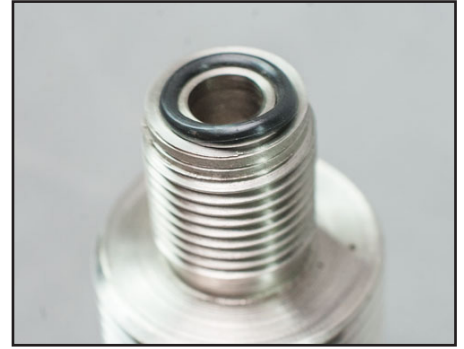
6. Replace o-ring if damaged with large o-ring from rebuild kit.

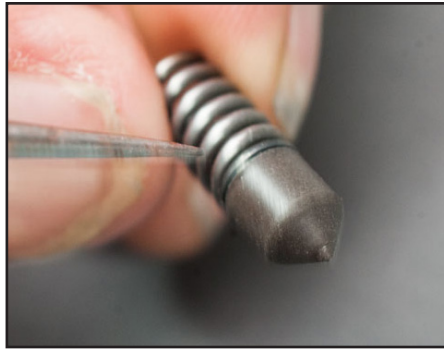
8. Make sure plunger is fully seated in spring.

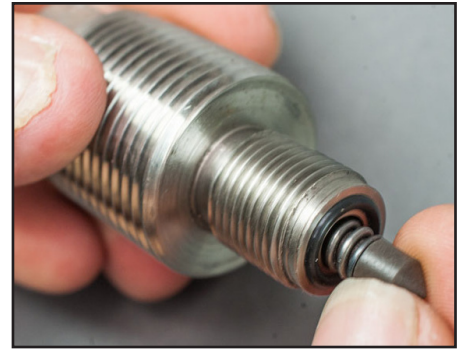
9. Replace plunger and spring assembly into the valve cartridge.

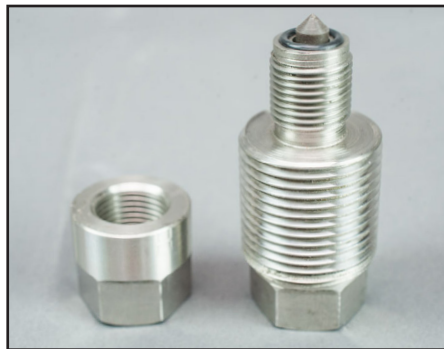
10. Make sure plunger is installed as shown.

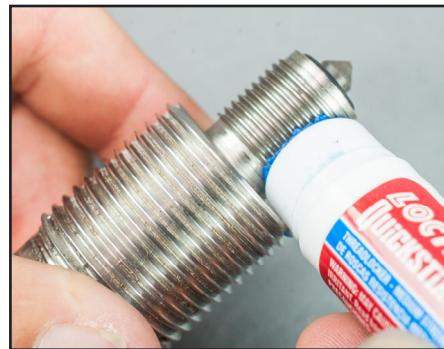
11. Apply a small amount of #248 "Blue" Loctite to the small threads.

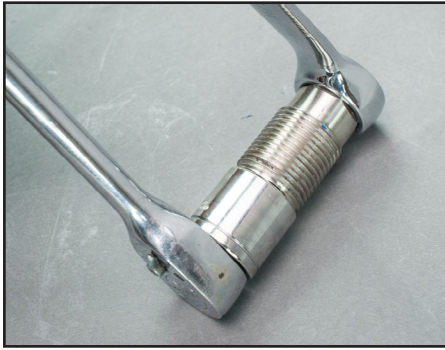
13. Tighten valve cartridge cap using the 7/8" wrench and the 7/8" ratchet. Tighten snugly. Torque to 45 ft/lbs.

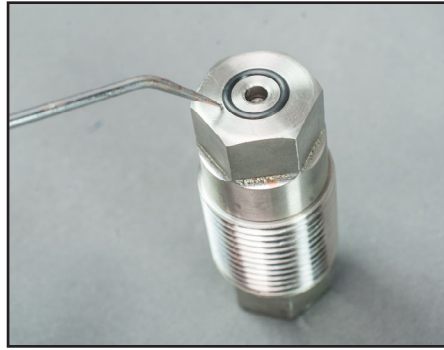
14. Inspect o-ring at end of the valve cartridge. If damaged, replace with large o-ring from the rebuild kit.

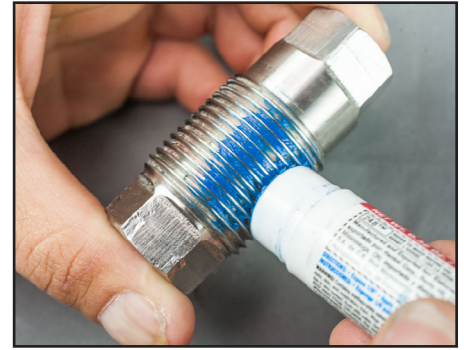
15. Apply a small amount of #248 "Blue" Loctite to the Large Threads.

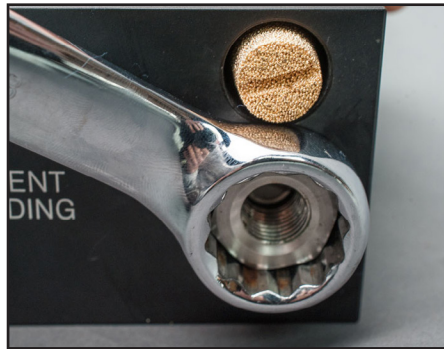
17. Tighten valve cartridge cap using the 7/8" wrench. Torque to 45 ft/lbs.

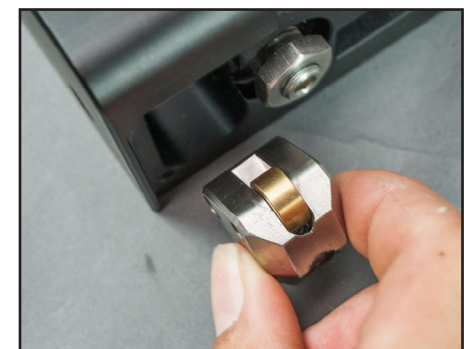
3. Remove the pivot.

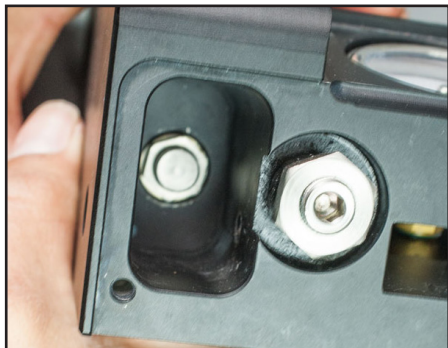
4. Note the 1/2" Hex fastener at the bottom of the pocket.

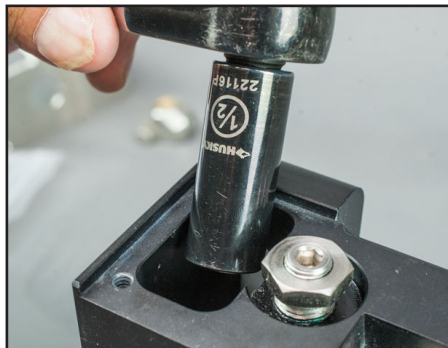
5. Using the 1/2" deep well socket, unscrew the 1/2" pin carriage.

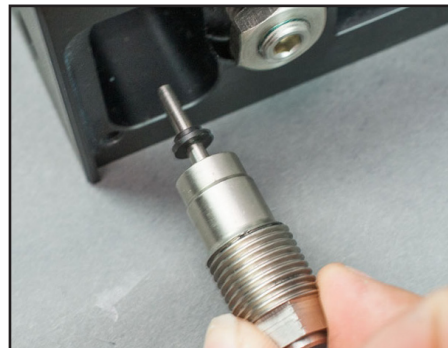
6. Remove pin and pin carriage

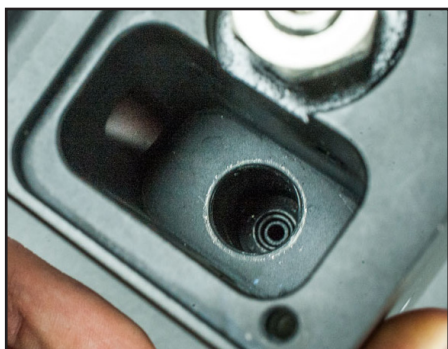
7. Replace plastic seat and small O-ring from the pocket using a small dental pick.

SOLUTION: Plastic seat and o-ring needs to be replaced

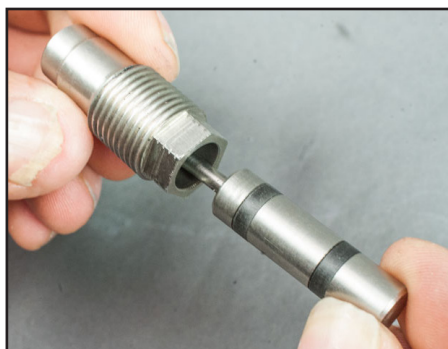
8. Remove the pin from the pin carriage.

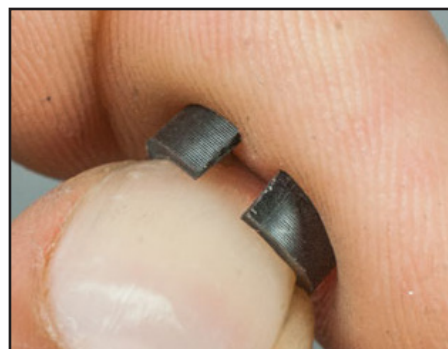
9. Inspect pin split bushings (they should be split). If worn, replace with new split bushings in the rebuild kit.

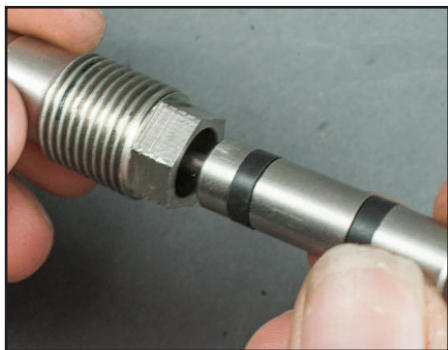
12. Reinstall pin into the pin carriage.

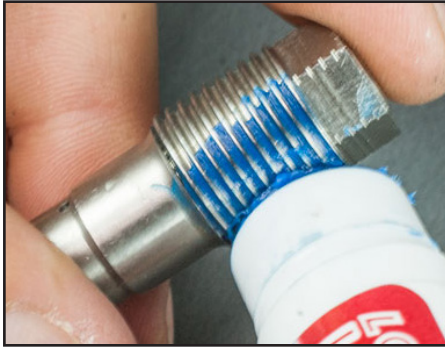
13. Apply a small amount of #248 "Blue" Loctite to outer threads.

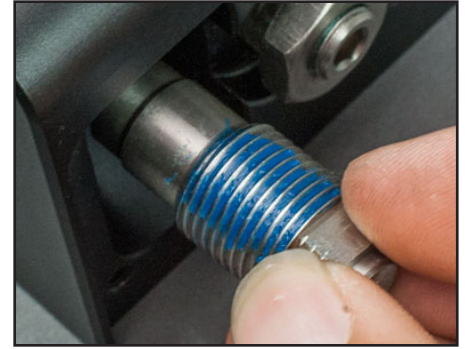
15. Reinstall pin carriage assembly into fill station.

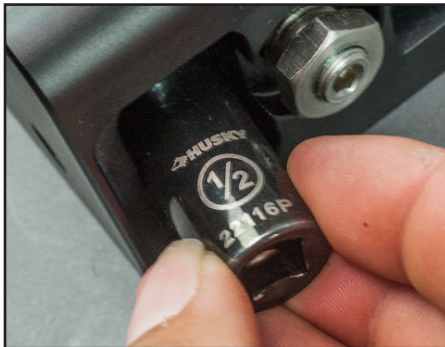
16. Tighten the pin carriage by hand using the 1/2" deep well socket.

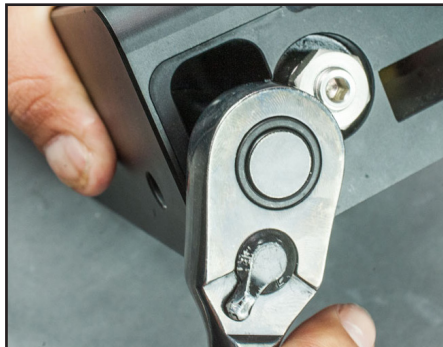
17. Snug pin carriage using 1/2" deep well socket and ratchet. *Do not overtighten.

SOLUTION: Pin carriage may be installed too tightly or plastic seat may not be seated correctly

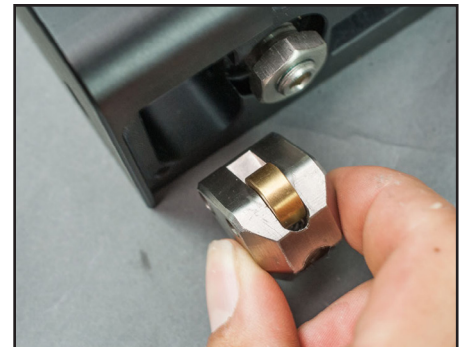
18. Reinsert pivot.

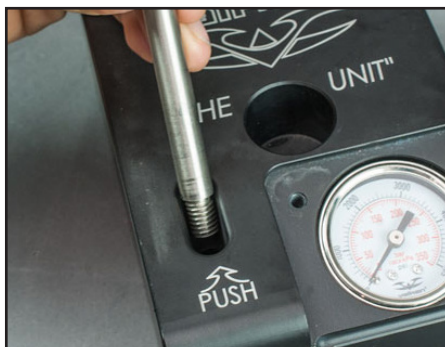
19. While sliding pivot into pocket, insert handle and screw into pivot.

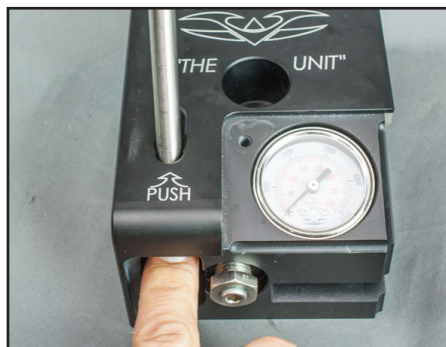
20. Hold handle to align pivot bolt.

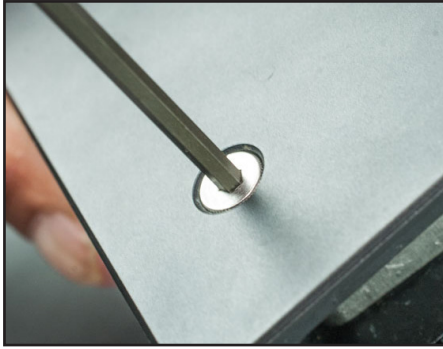
22. Tighten pivot bolt using 1/8" allen wrench.

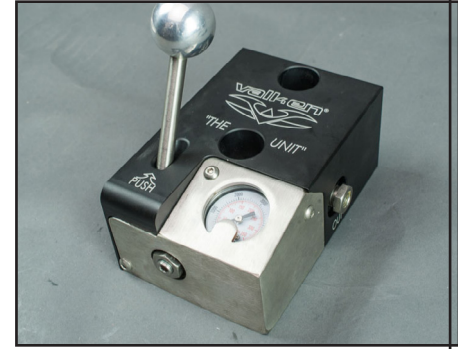
24. Finished product
